900 Polaris Tuning Tips

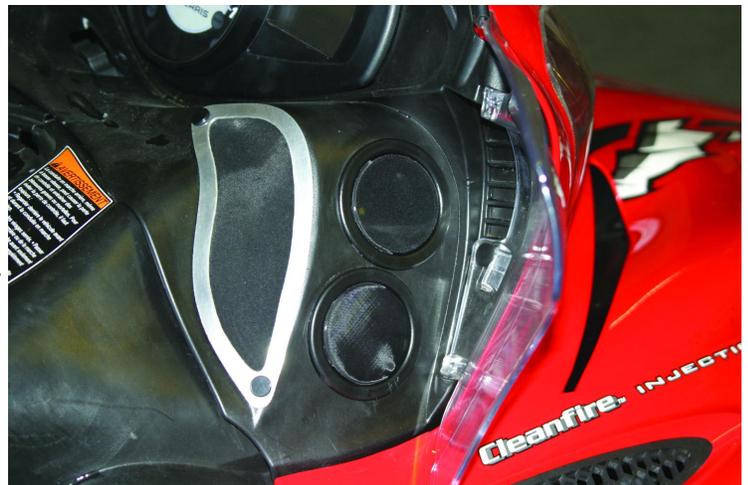
The Polaris 900 air intake system is very restrictive. To help deliver additional cold air flow into the intake tract we recommend installing 4 Flow-Rite™ Intake kits in the dash and gutting the stock air box. We are currently working on other air intake products and hope to have them available in the near future.
