## Important Technical Update

### Models - 2005/2006 Polaris RMK 900 2006 Polaris RMK 700

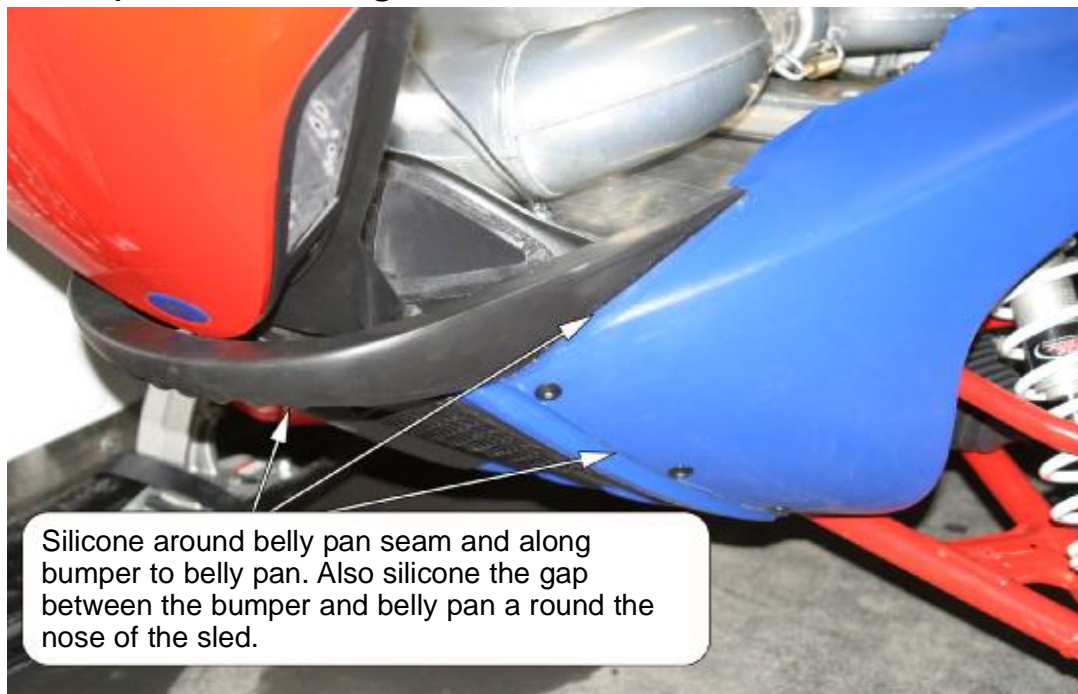
**Condition:** Air leaks in the belly pan seams allow powder snow to enter the under hood area.

**Correction:** Run a bead of silicone down the seams in the belly pan as well as the seam where the bumper and belly pan come together (see illustration below). NOTE: Make sure to seal the area where the belly pan and bumper come together around the nose of the sled.
