SLP *PicNic'R* Silencer for 2018-23 Polaris 800 Titan P/N 09-339

Installation Instructions:

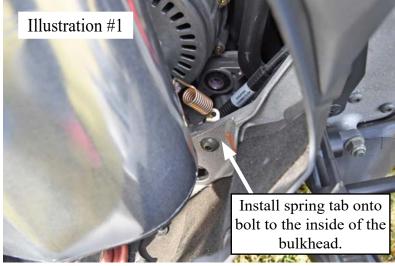
- 2. Remove the front upper bolt on the bulkhead. Slide the supplied spring tab onto the bolt and reinstall with the spring hook to the inside of the bulkhead pointing straight up. (see illustration #1)
- 3. Install upper vibro insulator from the stock silencer into the SLP Silencer upper support.
- 4. Install stock grafoil seal on pipe outlet.
- 5. Install SLP Silicone Outlet Ring onto the outlet of the silencer with rounded edge down (see illustration #2). Install silencer into sled, aligning the silicone seal so that it insets into the stock outlet rubber. Use the 2 medium springs supplied (Part #090-47) to spring the pipe to the silencer (see illustration #3). Use one short stock spring to spring the bottom of the silencer to the spring tab installed in step 2. Use the long stock spring that hooks around the chassis support to spring to the top of the silencer.
